Manhole Inspection Summary

Manhole # S29SS1005MH

Insp Date: **6/19/07 1:59 PM**

Location Address: **4802 WILMSLOW RD**

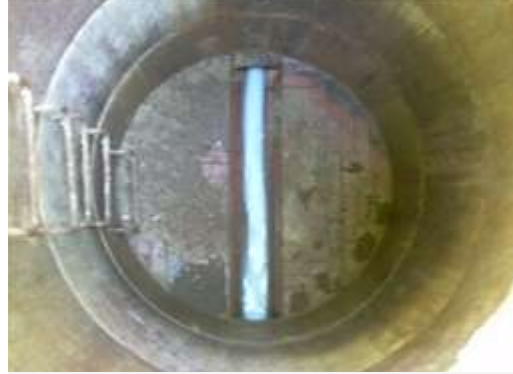
Top View

Bench ☒ Exists Material: **Brick** ☐ Parged ☒ **Debris** (not Condition related)

Bench debris.

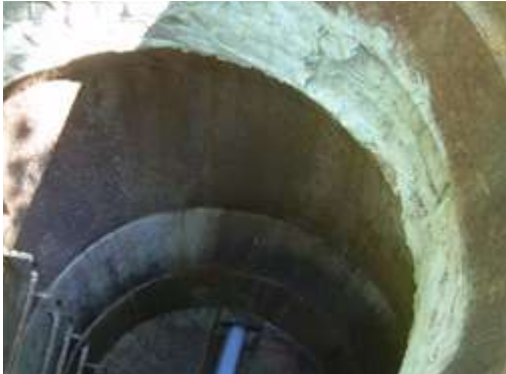
Defect

☒ **Leaks**

Infiltration: ☐ None ☒ **Joint** ☐ Cracks ☐ Mortar ☐ Roots ☐ Wall

Frame leaks. Corbel infiltration.

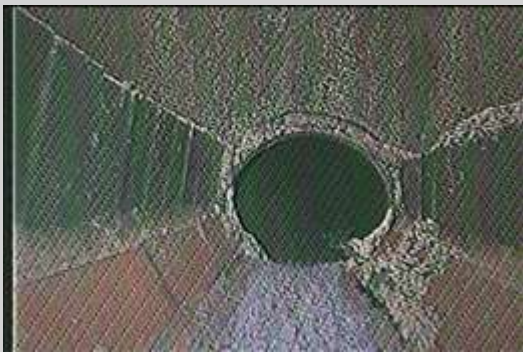
8 in. Circular Gravity Sewer Pipe Out @ 12 O'Clock

Deposits: ☐ None ☐ Mud ☐ Sludge ☐ Debris ☒ Grease

Silt Depth: **0** (in.) Deposits Extent: **Light**
